## 호주 전동차 2층 플로어 화재 저항 시험 결과 고찰

### A Study of the Fire Resistance for upper floor Test Result of Australia New Intercity Fleet

**초 록** 본 논문에서는 호주 전동차 2층 플로어 화재 저항 시험(Fire Resistance test) 절차 및 결과에 대하여 고찰하고자 한다.

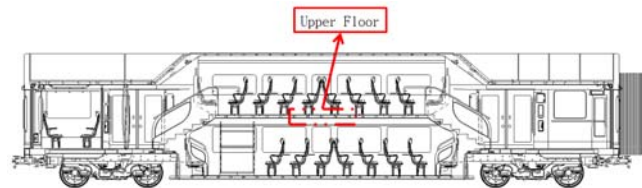
**Fig. 1** Location of Upper Floor

호주 간선형 전동차에서는 중량 및 구조 개선을 위하여 2층 플로어(Upper Floor)를 알루미늄으로 프로파일로 설계 하였으며, 단열재를 넣는 대신 방염 도료를 2층 플로어 하부에 도포하여 화재 성능을 만족하고자 했다.

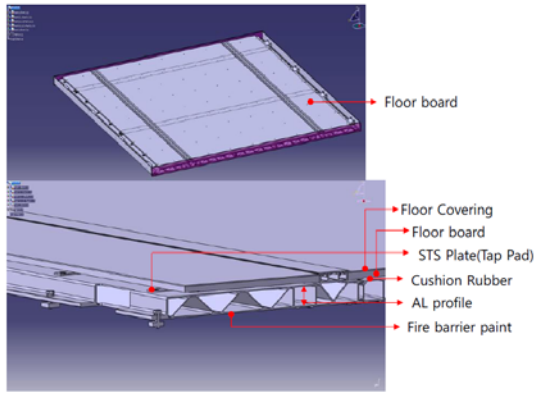
No	Description	Material
1	Floor Covering	Synthetic Rubber, 2.5 mm thick
2	Floor Board	Plywood, 18 mm thick
3	Cushion Rubber	Neoprene Rubber, 2.5 mm thick
4	STS Plate(Tap Pad)	SUS304L, 4 mm thick
5	AL Profile	Aluminum(6005A-T6), 50 mm thick
6	Insulation	Fire Barrier Paint, 1 mm thick

**Fig. 2** Section view of Upper Floor

Upper Floor : 3500mm(L) X 2980mm(W)

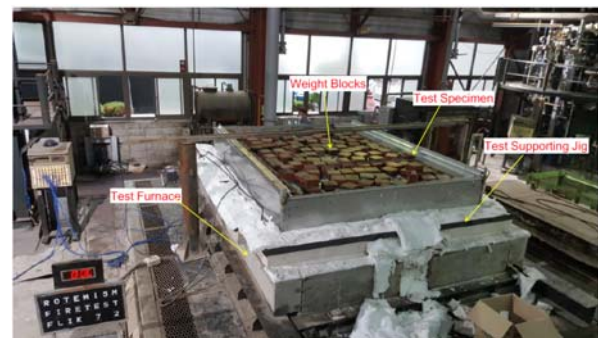
**Fig. 3** Setup Test Specimen

- a) The test specimens were set on the light oil-fired horizontal furnace.
- b) The thermocouples were installed at locations on the unexposed surface.
- c) The representative load condition was applied to upper floor using weight blocks. The deflection gauge was installed at the centre of upper floor.
- d) The temperature of furnace was controlled by readings of nine thermocouples located in the horizontal furnace chamber. The furnace temperature was recorded over time.
- e) The unexposed surface temperatures of upper floor were recorded over time.
- f) The deflection at the centre of upper floor was measured over time.
- g) Observations were made on the behaviour of upper floor for compliance with the relevant criteria during test.

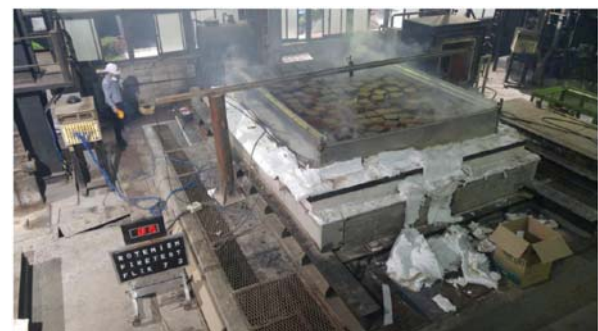
**Fig. 4** End of Test (Time = 15min)

- No sustained flaming on the unexposed surface.
- No cracks, and openings of the test specimen.

The test specimen of upper floor has 15 minutes fire resistance performance. (integrity, insulation, structural integrity)
